## **TF2000 Stair Fire Test Summary Report**

Report reference: TF2000 – Stair Fire Test

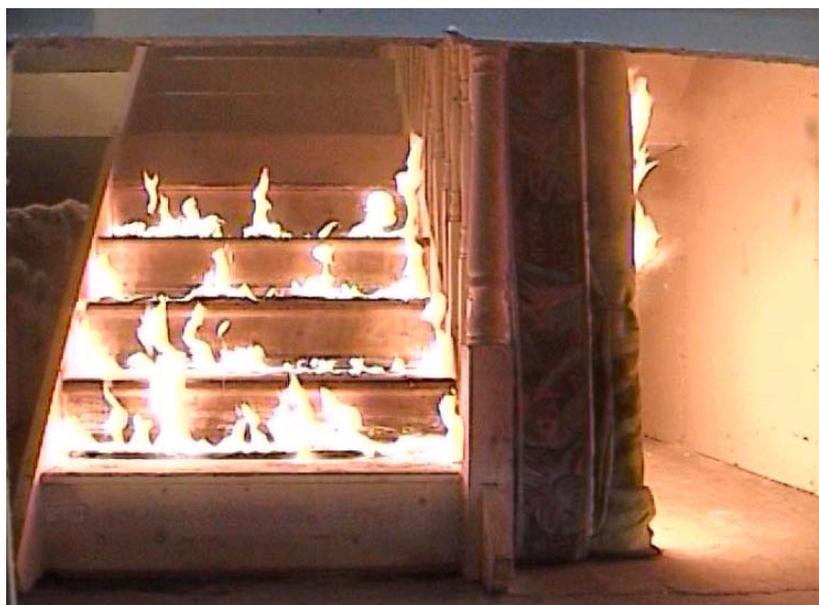
Figure 5 – Trial 2 mattress & fibre strip fire

The mattress fire test did not cause any significant damage to the stair. The treatment clearly provided an enhanced performance over that observed during Trial 1. The mattress burned for approximately 13 minutes. The inclusion of the fibre strips on the treads of the lower flight led to limited charring (approximately 5mm) on the face of the risers in the immediate area around the fibre board. However, there was no evidence of flaming on the nosing, string or even on the treads and risers remote from the fibre strips. In general the spindles on the lower flight remained intact with only limited localised charring on the handrail closest to the mattress. Surface charring was observed on the lower string to a depth of 6 or 7mm with a maximum depth in a very localised area of 10mm or approximately half the thickness. In general there was no spread of flame away from the immediate vicinity of the mattress. There was limited charring (approximately 3mm) on the upper flight spindles and a similar level on the upper string.

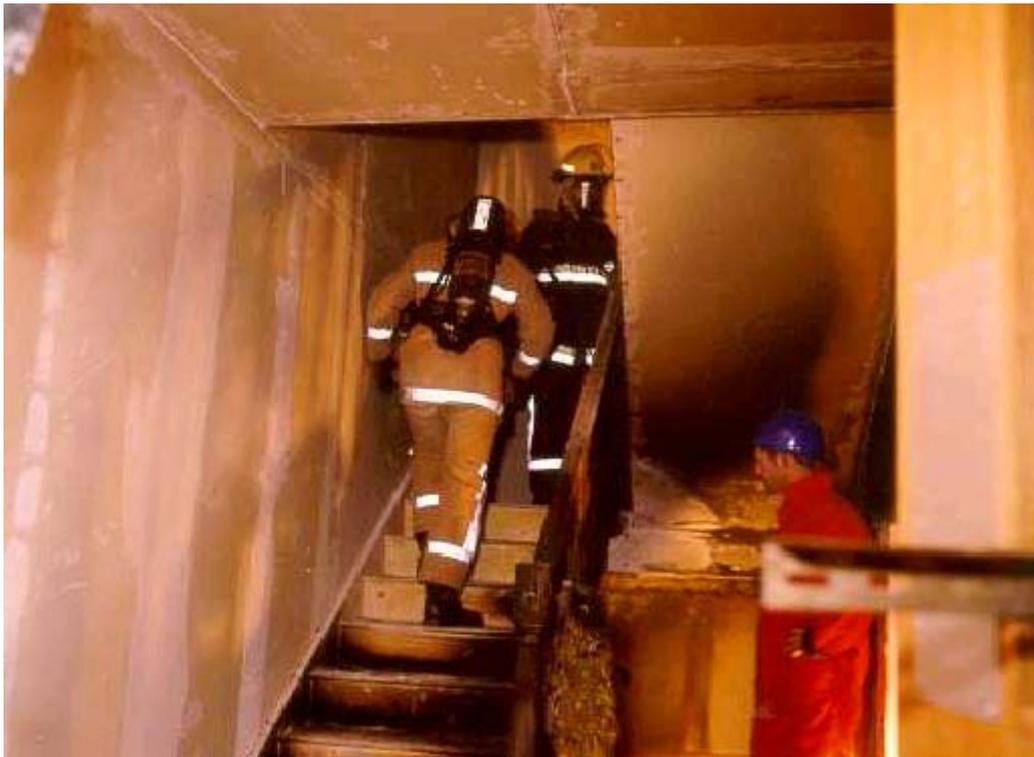
Figure 10 – Fire-fighters accessing upper storeys using stair after fire exposure

Following complete combustion of the fire load, the stairs were visually inspected to ensure that they were still serviceable. There was limited charring to the exposed stringers, the handrail and the spindles. To demonstrate the ability of the stairs to continue to meet the functional requirement for access and means of escape, Fire Brigade personnel were asked to inspect the upper floors using the stairs for entry. Fire fighters in full breathing apparatus were able to access all levels without any difficulty – see figure 10.
