## **TF2000 Stair Fire Test Summary Report**

Report reference: TF2000 – Stair Fire Test

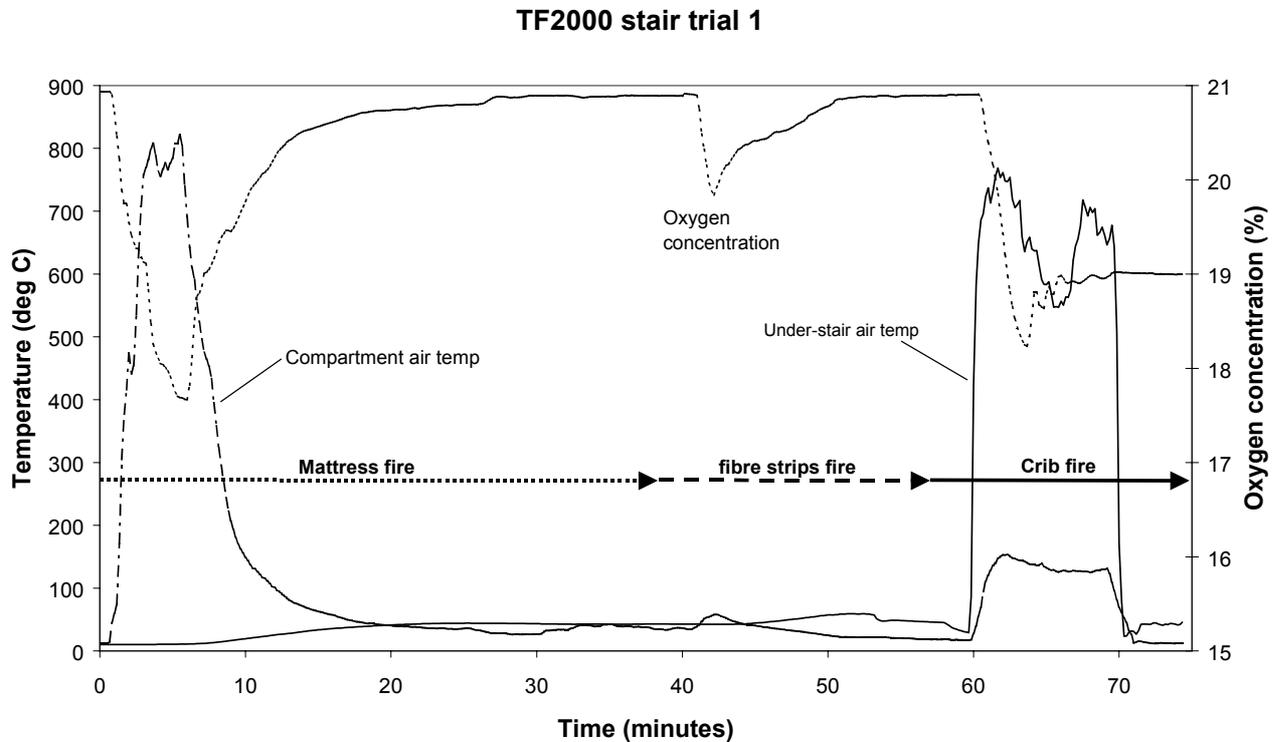
Figure 3 – data from Trial 1

The stairs for the first trial were not provided with a fire retardant treatment. In the trial complete combustion of the mattress took place. The spindles and handrail of the baluster were involved in the fire causing extensive charring to these members. However, virtually no damage was inflicted on the stair treads and risers, and only very limited charring to the vertical face of the lower stringer was observed.

Figure 3 shows the temperature of the lower flight of stairs, the air temperature immediately above the mattress and the oxygen concentration in the compartment over the complete duration of the trial.

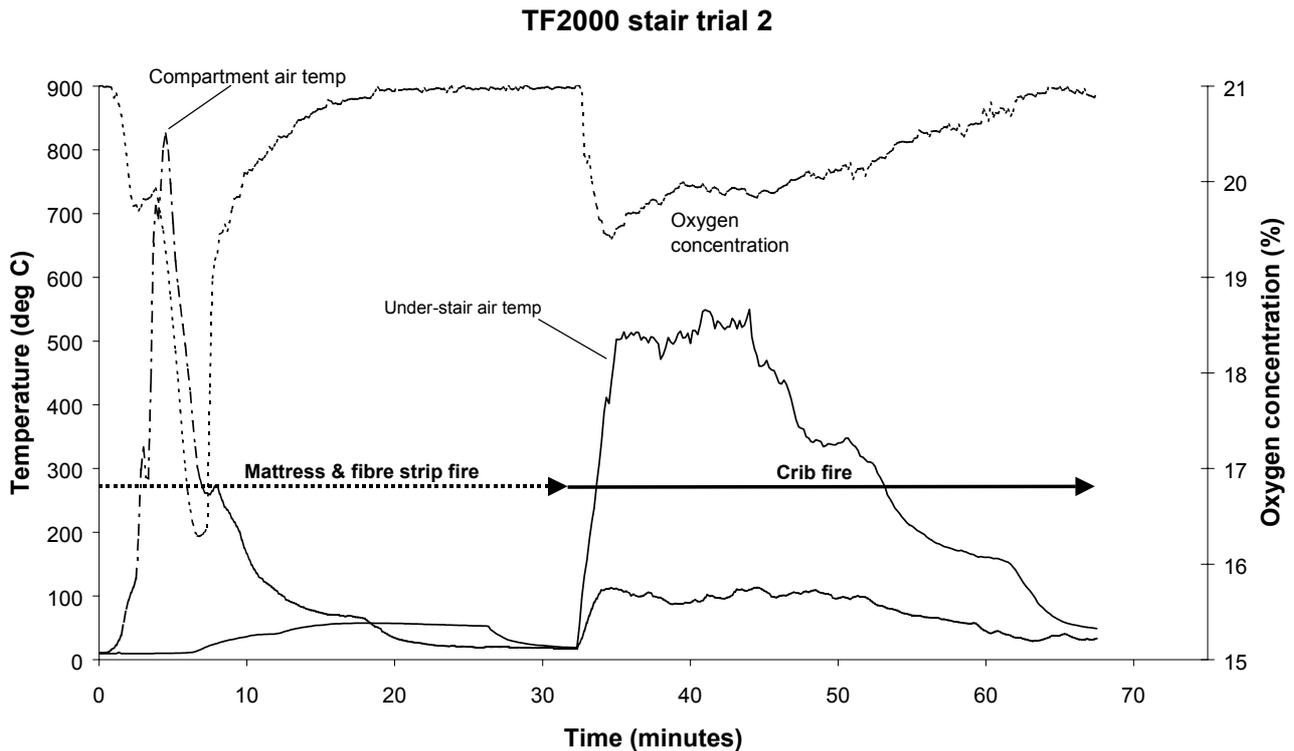
Figure 4 – data from Trial 2

The mattress fire test did not cause any significant damage to the stair. The treatment clearly provided an enhanced performance over that observed during Trial 1. The mattress burned for approximately 13 minutes. The inclusion of the fibre strips on the treads of the lower flight led to limited charring (approximately 5mm) on the face of the risers in the immediate area around the fibre board. However, there was no evidence of flaming on the nosing, string or even on the treads and risers remote from the fibre strips. In general the spindles on the lower flight remained intact with only limited localised charring on the handrail closest to the mattress. Surface charring was observed on the lower string to a depth of 6 or 7mm with a maximum depth in a very localised area of 10mm or approximately half the thickness. In general there was no spread of flame away from the immediate vicinity of the mattress. There was limited charring (approximately 3mm) on the upper flight spindles and a similar level on the upper string.

Localised flaming was observed on the second step some 12 minutes into the crib fire although this remained localised until the test was completed. The steps immediately over the crib sustained severe damage but this did not lead to fire spread away from the crib location. At no stage did the fire spread towards the half landing or the upper flight. Complete combustion of the crib was reached after approximately 30 minutes with no intervention necessary in contrast to the first trial.

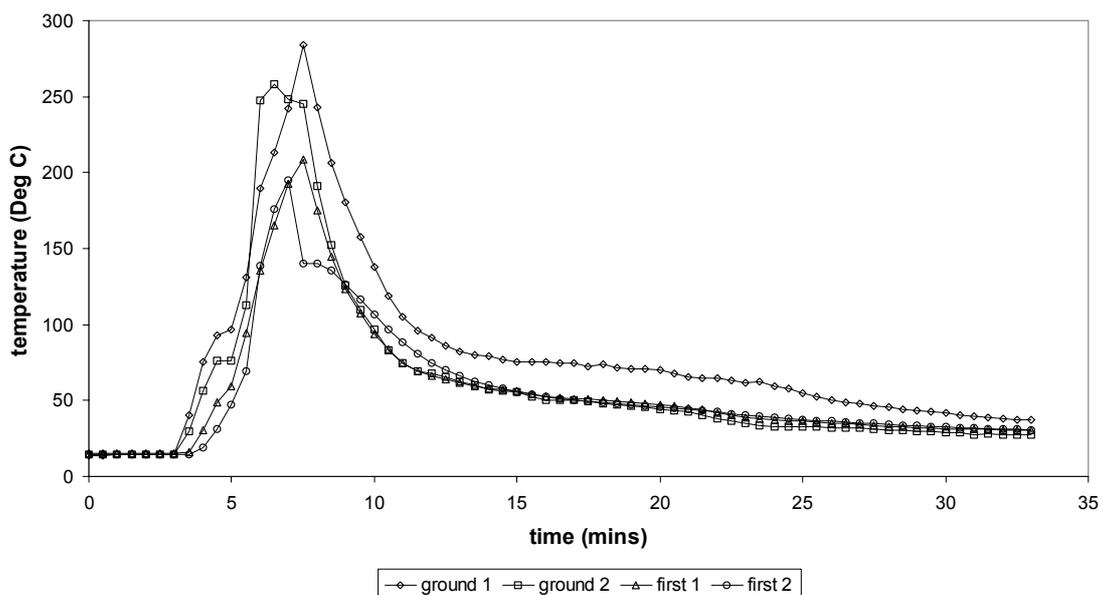
Figure 6 – stair shaft air temperatures ground and 1<sup>st</sup> floor (levels 1 & 2)

The air temperatures at first and ground floor level are shown in figure 6. Air temperatures remained below 300°C. The peak temperature is due largely to the peak rate of heat release associated with the mattress as no combustion of the handrail or spindles took place. The location of the timber crib provided a worst case in terms of the thermal exposure to the stairs although this meant that the effect of the crib was very localised in terms of the air temperature in the shaft.

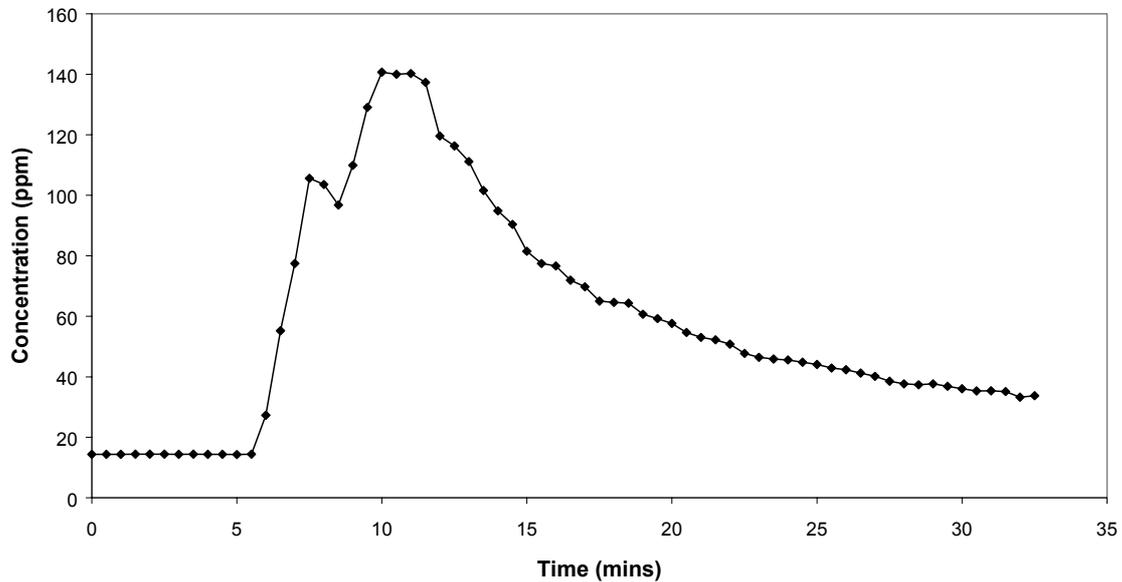
Figure 7 – carbon monoxide concentration measured in protected lobby at 5<sup>th</sup> floor

Figure 7 shows a record of carbon monoxide concentration monitored close to the 5<sup>th</sup> floor lobby door on the lobby side at approximate head height. What is noticeable is that the increase in detectable carbon monoxide is concurrent with detector actuation in the lobby at which time the vent panel was removed to simulate automatic ventilation of the lobby. The peak carbon monoxide concentration measured in the lobby was approximately.

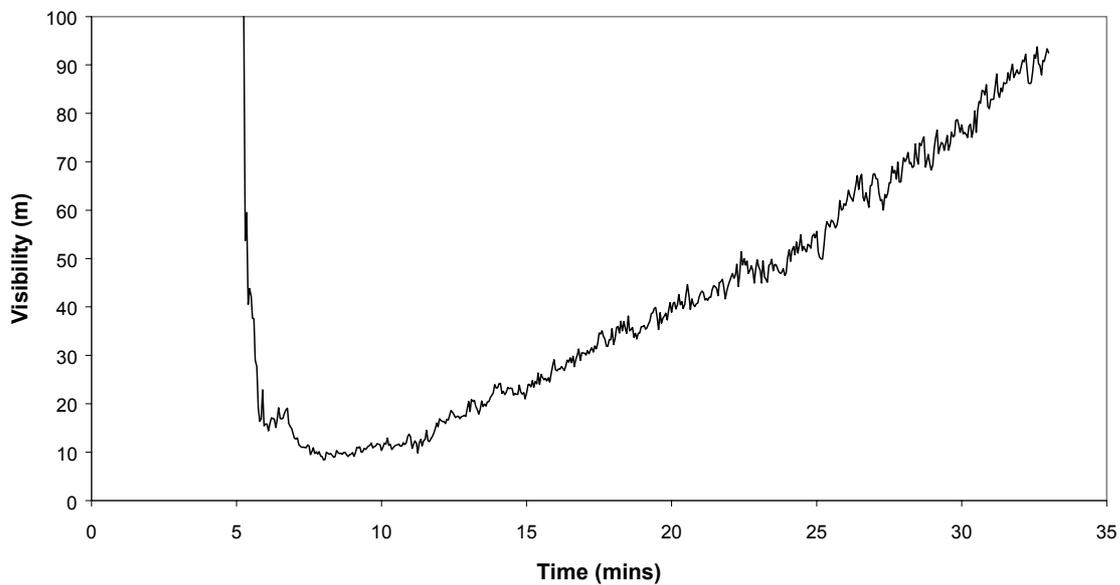
Figure 8 – visibility monitored in 5<sup>th</sup> floor lobby

The results of visibility measurements shown in figure 8 indicated that the visibility diminished to about 10m and the time of duration of the low visibility was coincident with peak carbon monoxide levels.

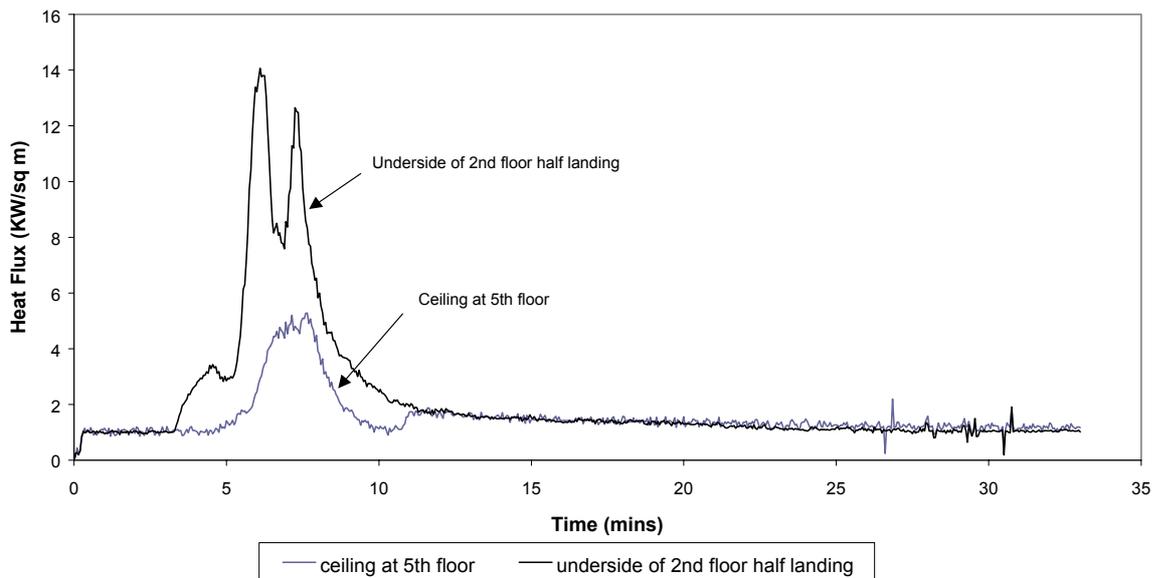
Figure 9 – heat flux levels in stair shaft

Figure 9 shows levels of heat flux measured in the stair shaft. At the underside of the 2<sup>nd</sup> floor half landing the peak heat flux level reached 14 KW/m<sup>2</sup> which is sufficient to cause the pilot ignition of timber under sustained exposure. At 5<sup>th</sup> floor level the peak heat flux was significantly lower with a peak value slightly in excess of 5 KW/m<sup>2</sup>. This level of heat flux is tolerable for about 12 seconds without suffering severe pain.
