Technical information

Acoustic testing

Achieving compliance

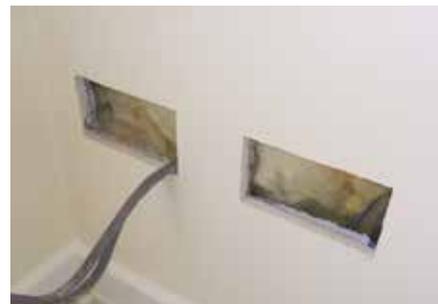
Socket backing boxes can allow sound to pass in and out of walls.

One of the main details that can cause issues are service penetrations through the wall linings, i.e. switch socket backing boxes which allow sound to pass in and out of the wall. Typically the switch socket backing boxes are fitted to noggings that are lined with plasterboard which continues the line of plasterboard behind the backing box and helps to maintain performance. It is also important that services are not installed back to back on a party wall.

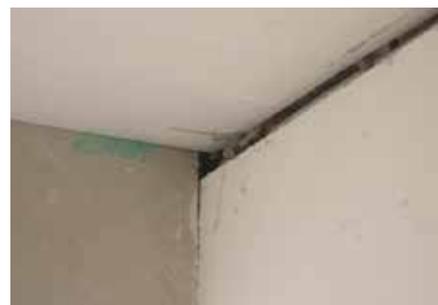
Manufacturer installation instructions and best practice guides should be closely followed when installing for best results.

If lightweight framed walls are installed within a masonry construction, care must be paid to the junction of wall linings and the surrounding constructions. Deflection head details are often specified which call for a gap between the top of the wall and the underside of a masonry floor slab. These gaps allow sound to easily pass through the head of the wall and lead to greatly reduced performance. Manufacturer installation instructions and best practice guides should be closely followed when installing for best results.

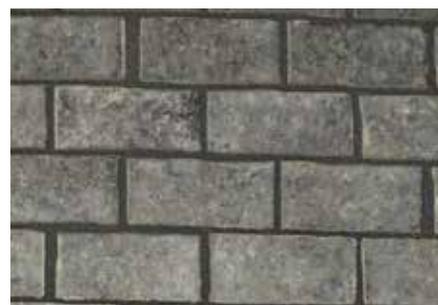
Small gaps at blockwork joints reduce overall performance.

One of the main causes of reduced performance is small air gaps at blockwork joints. These small gaps allow high frequency sound to pass through and reduce overall performance. As such, a parge coat or wet plaster finish helps to block and fill these small gaps.

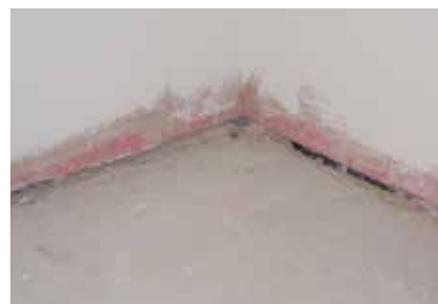
The floating floor layer must not come into contact with any of the surrounding structure.

As with lightweight walls, the performance of floors is based on mass and isolation. Typical floor specifications call for a 'floating floor' and a resilient bar ceiling. A floating floor consists of either foam clad timber battens on which the floor deck rests or a layer of dense mineral wool. This provides isolation and absorbs foot fall energy. The floor deck usually consists of a laminate of plasterboard and chipboard. It is important that this floating deck does not come into contact with the surrounding structure to ensure that the isolation created by the resilient battens or mineral wool is not bridged.

Both of these floors are usually overlaid with a resilient layer of foam and then a screed is poured on top. As with the lightweight floors, it is important that this floating layer does not come into contact with any of the surrounding structure.
